Appendix E: Hazards and Hazardous Materials

**Phase I and Limited Phase II
Environmental Assessment
111, 145, 153, 157, & 165 Chiquita Road
Healdsburg, California (Rev. 1)**

**Project No. REE-62-08A-15
September 1, 2015**

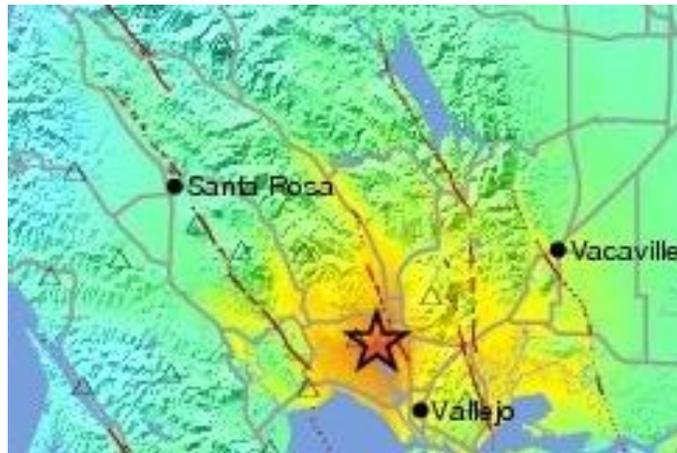
Figure 4 – CISN Seismic Map of South Napa Earthquake

The most recent notable seismic event was the South Napa Earthquake on August 24, 2014, at a magnitude of 6.0 on the Richter scale (Figure 3). The earthquake damaged infrastructure in South Napa and Vallejo and interrupted power for 69,000 residents. The City of Healdsburg, approximately 38 miles from the epicenter, experienced the event but sustained no significant damage (Lazo and Campoy, 2014).

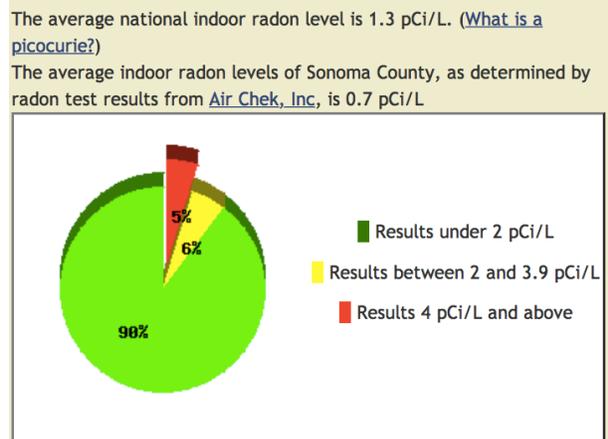
Figure 5 – Radon in Sonoma County

According to the EPA’s Map of Radon Zones for California, dated September 1993, Sonoma County is in radon zone (3). Areas within radon zone (3) have an average predicted indoor radon screening potential less than 2 picocuries per liters (pCi/L). Levels greater than 4 pCi/L may be considered hazardous. The average predicted first floor living space radon levels in Sonoma County is 0.075 pCi/L. Figure 5 is a Pie Chart of Radon Levels in Sonoma County

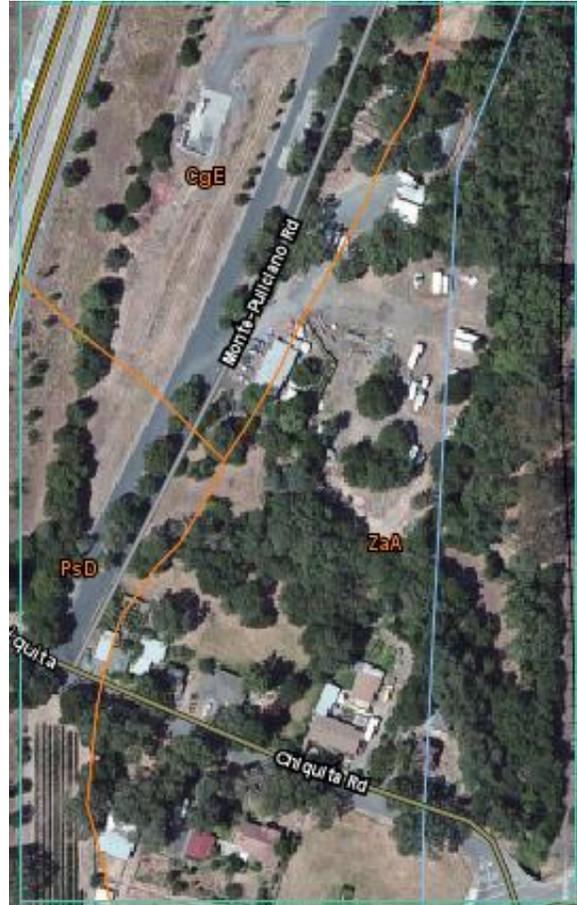
Figure 6 – USDA Soil Survey

Figure 6 and accompanying information was developed from the United States Department of Agriculture (USDA) Soil Survey. The site soils are primarily designated
 ZaA- Zamora silty clay loam, 0-2% slopes

- National map unit symbol: hfl3
- Elevation: 30 to 1,300 feet
- Mean annual precipitation: 22 in
- Mean annual air temperature: 61°F
- Frost-free period: 250 to 330 days
- Farmland classification: Prime farmland if irrigated

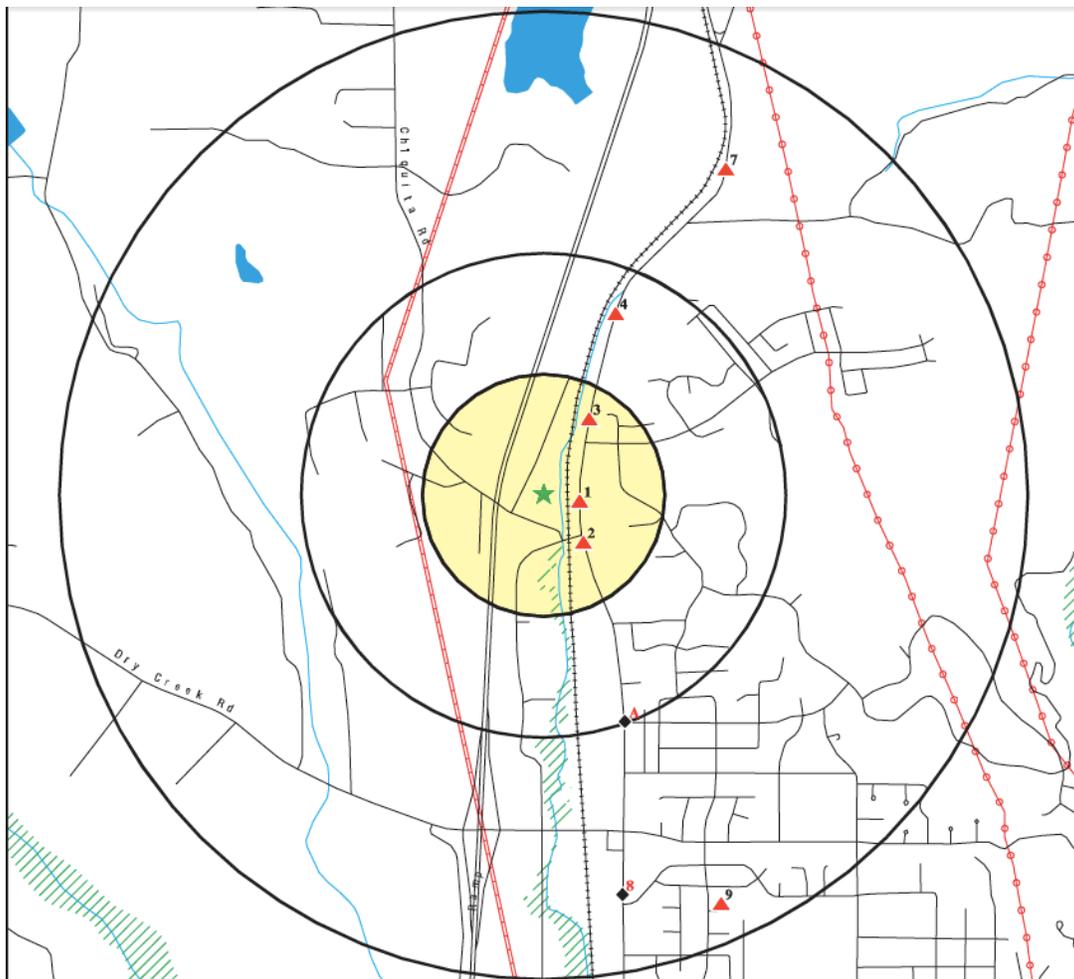
Figure 18 – EDR Database Radius Map

Figure 18 maps the sites listed on the EDR database search report. Table 7 lists the reported nearby sites of potential concern.

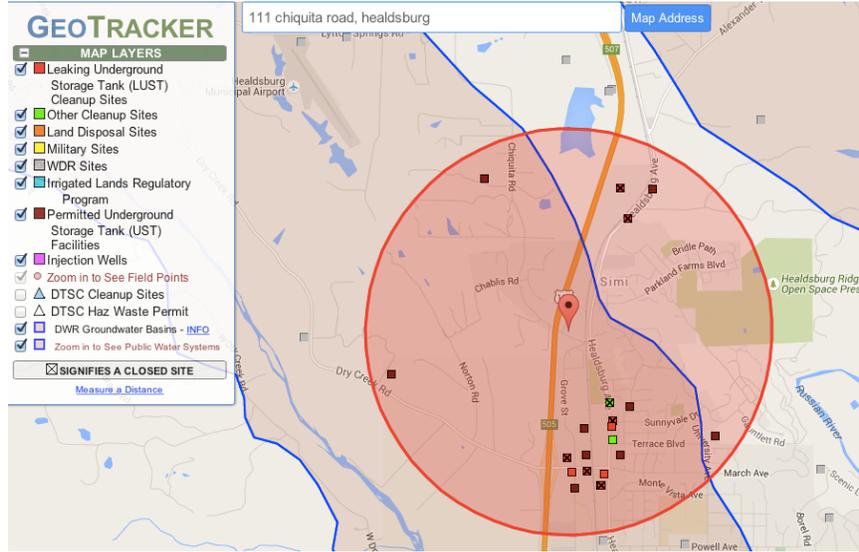
Figure 19 – Geotracker Radius Search

There were no additional sites listed as release sites on either of these state-run database tracker websites. The two sites mentioned on the EDR, Inc., report as being mismapped were also mismapped on the Geotracker website.

- The subject Site is not listed on the Geotracker website,
- There are no Land Disposal Sites within 1 mile of the Site.
- There are no Military sites within 1 mile of the Site.
- There are no Waste Discharge Requirements sites within 1 mile of the Site.
- There are no Irrigated Lands Regulatory Program sites within 1 mile of the Site.
- There are no Injection Wells within 1 mile of the Site.

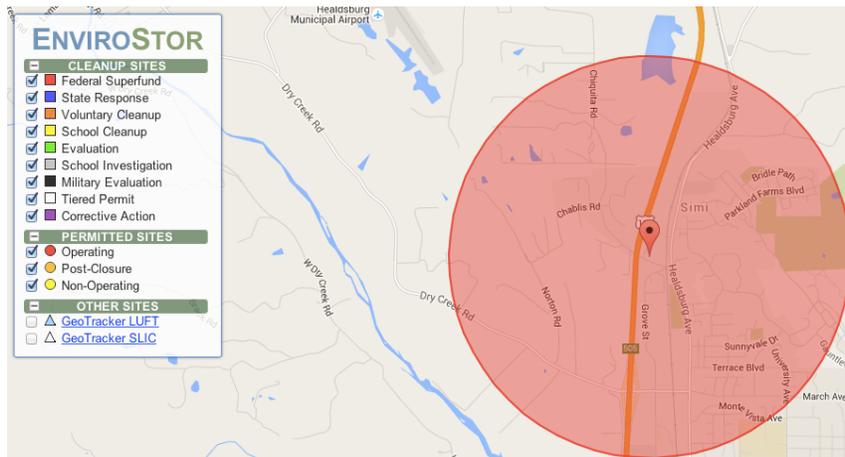
Figure 20 – Envirostor Radius Search

- The subject Site is not listed on the Envirostor website,
- There are no Federal Superfund Sites within 1 mile of the Site.
- There are no State Response sites within 1 mile of the Site.

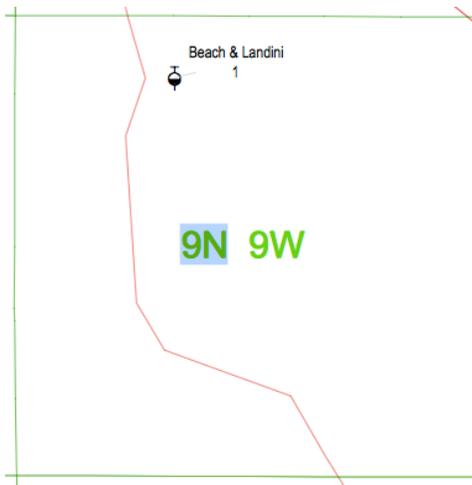
Figure 21 – Beach & Landini 1 Well Map

No Oil and Gas Wells are located within a 1-mile radius of the subject Site according to the EDR GeoCheck database. The State of California Department of Conservation, Division of Oil, Gas and Geothermal Resources (DOGGR, 2015) website indicated that the only oil or gas well within the Township 9N, Range 9W of the Site vicinity is the Beach & Landini 1 well (Figure 21). The well was drilled in 1922 and marked as plugged in 1923 (Figure 22).

Well Details				
API: 09700050	Well Status: Plugged	District: 6		
Operator: Beach & Landini	Operator Code: 00673	Operator Status: InActive		
Lease: [BLANK]	Well Number: 1	County: Sonoma		
Field: Any Field	Field Code: 000	Area: Any Area	Area Code: 00	
Section: 4	Township: 9N	Range: 9W	BaseMeridian: MD	Latitude: 38.652409
				NAD83
Spud Date: 12/21/1922	Abandonment Date: 1/1/1923	Longitude: -122.871034	NAD83

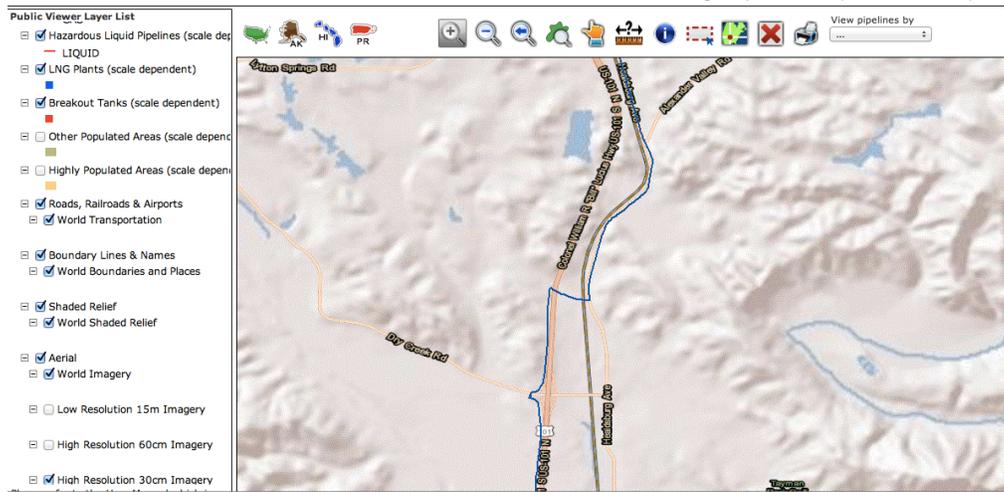
Figure 23 – National Pipeline Mapping System

According to the EDR, Inc. Radius Map (Figure 24) search, an oil or gas transmission pipeline is located more than ¼-mile west of the Site (EDR Radius Map, 2015). However, no other information is provided in the report and the pipeline is not mapped within the NPMS website. This pipeline is more than a quarter mile to the west of the site and not reported as having a release detected that poses a threat to the Site in any of the databases searched.

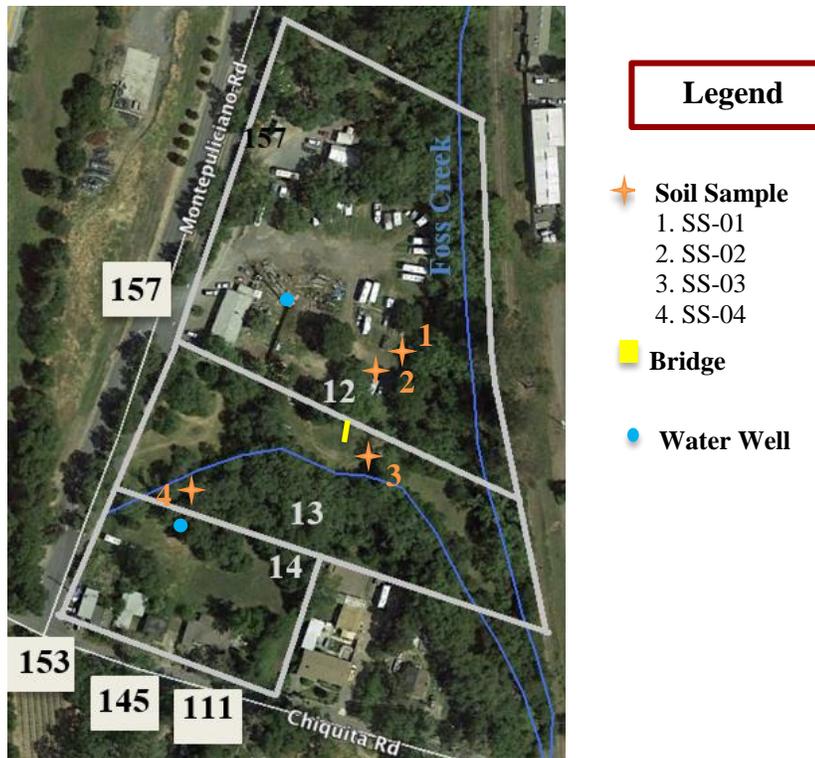
Figure 24 – Targeted Sampling Map

During an initial reconnaissance of the Site on July 30, Rosewood Environmental Engineering identified four sites for targeted soil sampling. Figure 24 maps the sampling locations of SS-01 through SS-04. Table 11 provides the rationale for targeted sampling and analysis performed on each sample.
